Air leakage test of a circular duct system

Air leakage test of a circular duct system made of moulded glass wool.

SP Technical Research Institute of Sweden

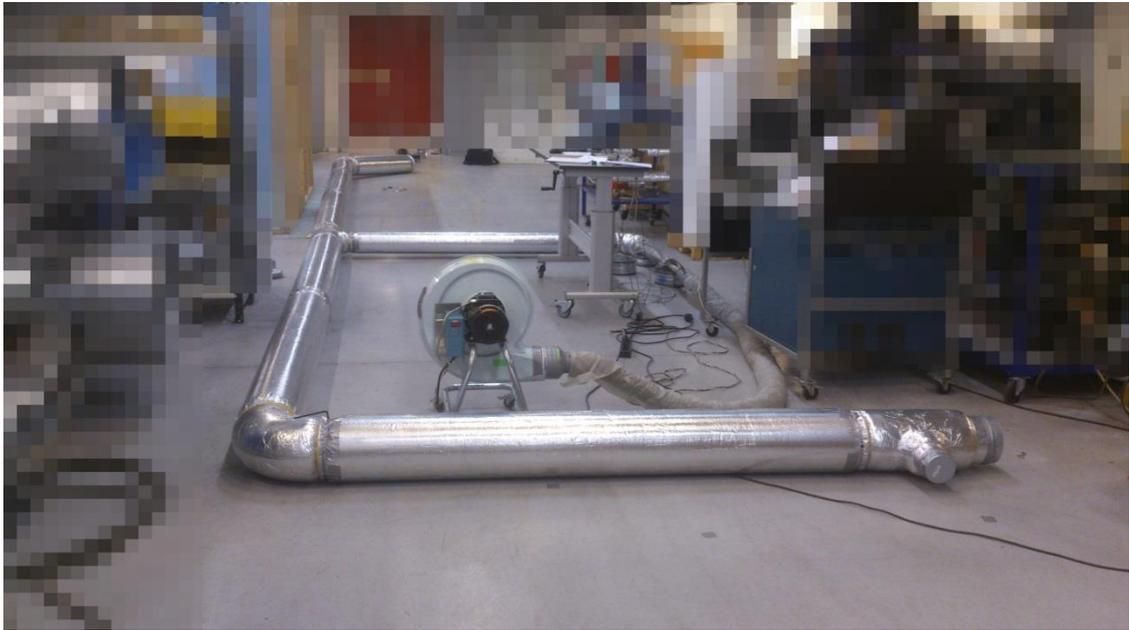
Figure 1. Photo of the tested system.

Circular duct system consisting of:
5 pcs. 2.35 meters duct, Ø 200 mm.
2 pc. 1.17 meters duct Ø 200 mm.
1 pc. 2.35 meters duct Ø 125 mm.
2 pc. T-connection Ø 200 – 125 mm.
1 pc. Bend 90° Ø 200 mm.
1 pc. Bend 45° Ø 200 mm.
1 pc. Bend 90° Ø 125 mm.
2 pc. Endplate Ø 200 mm.

The system consisted of ducts made of moulded glass wool. Duct Ø 125 mm has an outside diameter of Ø 195 mm and duct Ø 200 mm has an outside diameter of Ø 275 mm.

For photos of the duct system, see appendix 1.

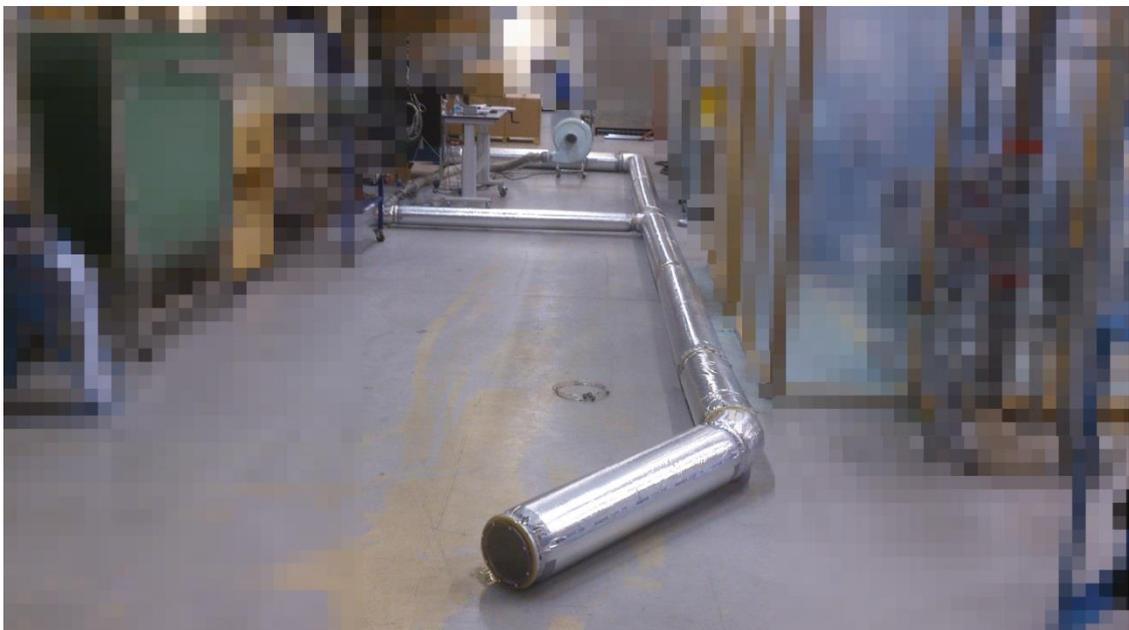
Figure 2. Photo of the tested system.

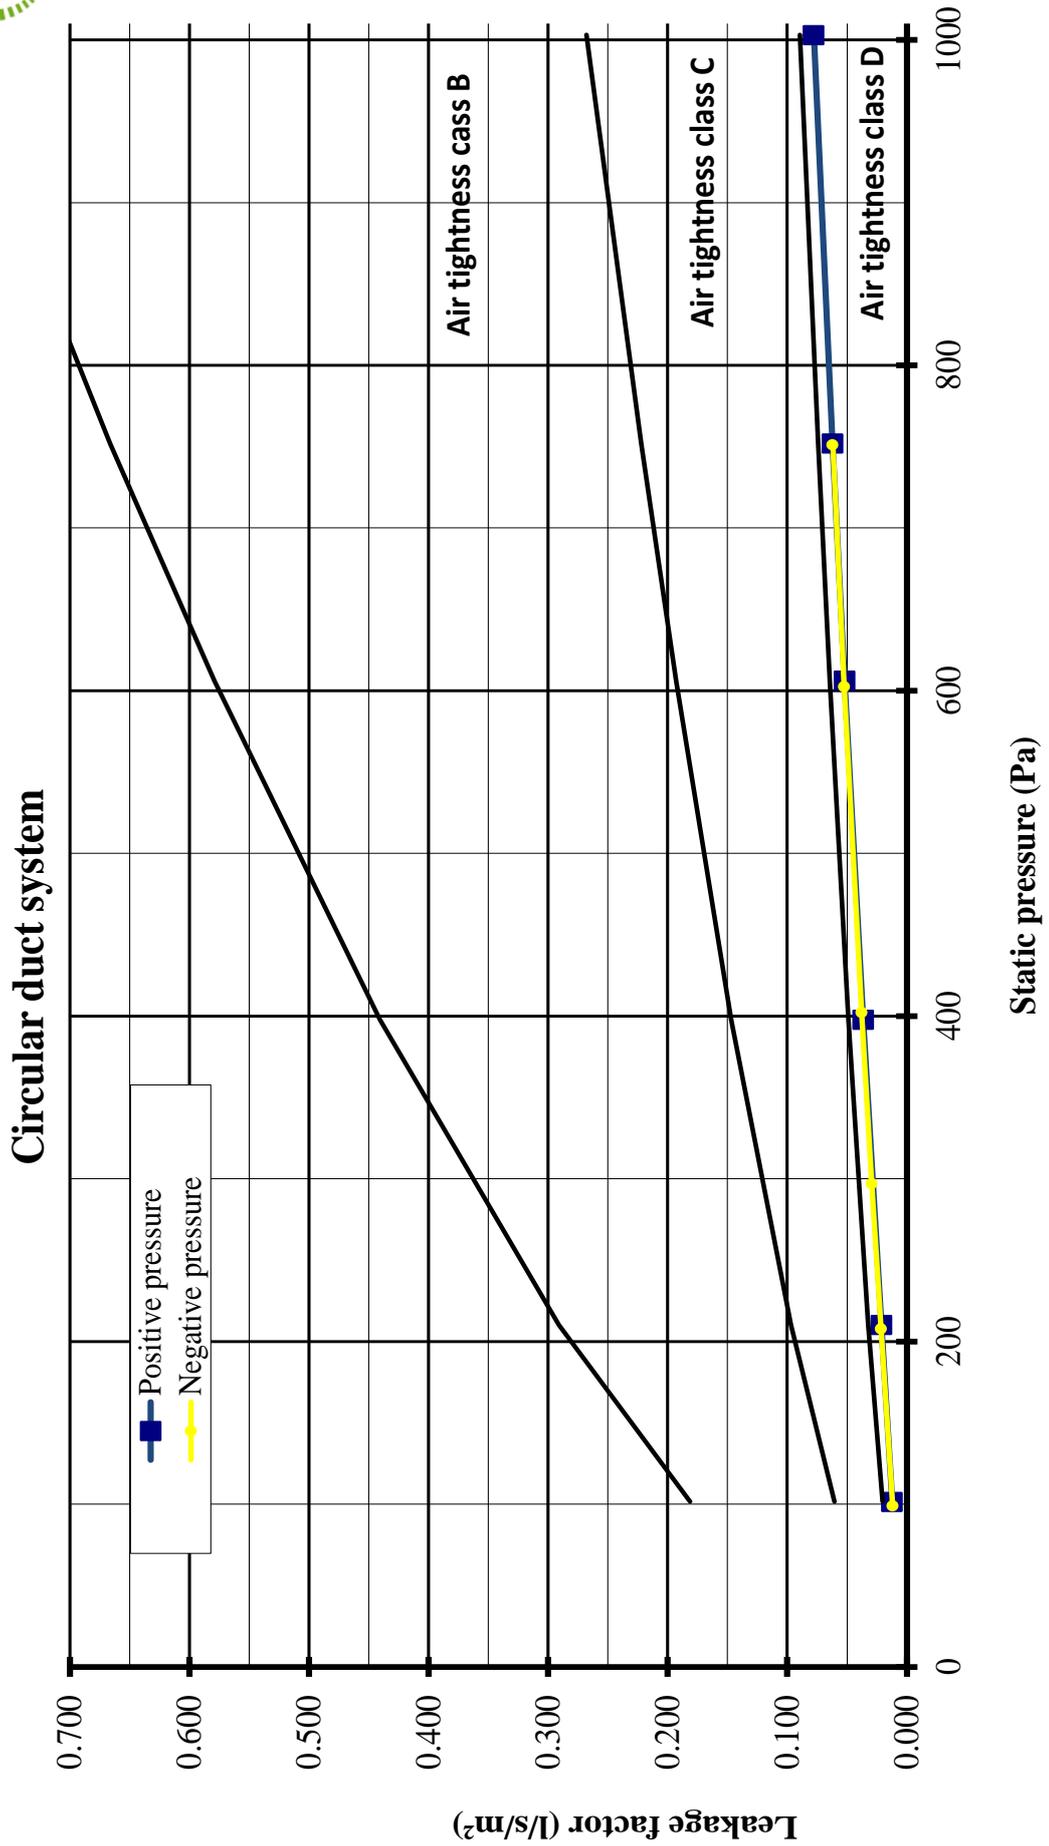
Appendix 2

1. Figure 1 and 2. Photo of the tested system.
2. Diagram: Leakage factor [l/s/m^2] as a function of static pressure [Pa].

The measured and calculated values for pressure and air leakage factors are presented in tables 1-2 and in the diagram in appendix 2.

At the actual test the system achieved air tightness class D at pressure class 2 according to EN 1507:2006.
